# **ARBORICULTURAL REPORT**

## **Health and Condition Survey**

**Location : Havelock Park  
Havelock Street  
Llanelli  
SA15 2BW**

**March 2025**

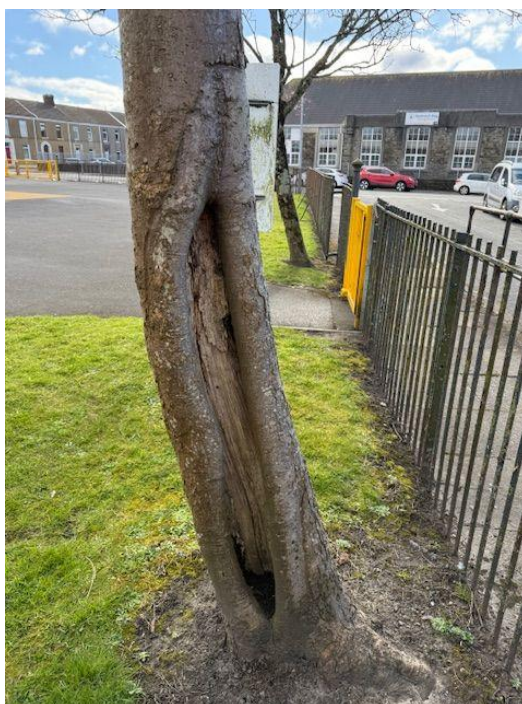
| 278 | Sycamore | SM | S | F | P | Basal decay and cavity at base of tree on north side - IMAGE A. | 0 | M |

**IMAGE A: Basal cavity of tree 278**

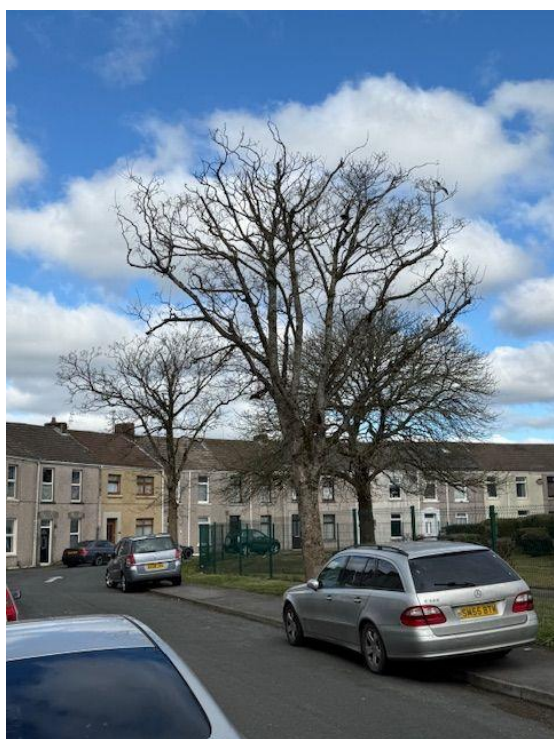
| 281 | Sycamore | EM | M | P | P | Minor dieback in upper crown, very low vigour and extension growth - IMAGE B. Cavity on main stem at 2.5 metres above ground level. Remove all deadwood. Refer to the additional information below. | 2 | M |
| 282 | Sycamore | EM | S | P | P | Very low vigour and upper crown dieback - IMAGE B. Remove all deadwood. Refer to the additional information below. | 2 | M |

These two Sycamore trees are in gradual physiological decline but their structural problems can be rectified with some minor pruning i.e. removal of the small diameter deadwood. If this dead wooding is undertaken the trees can be retained with minimal management for a number of years.

**IMAGE B: Trees 281 and 282, centre and left.**

Due to the above facts I would recommend that these two trees have all their deadwood removed and are reinspected in 2027.

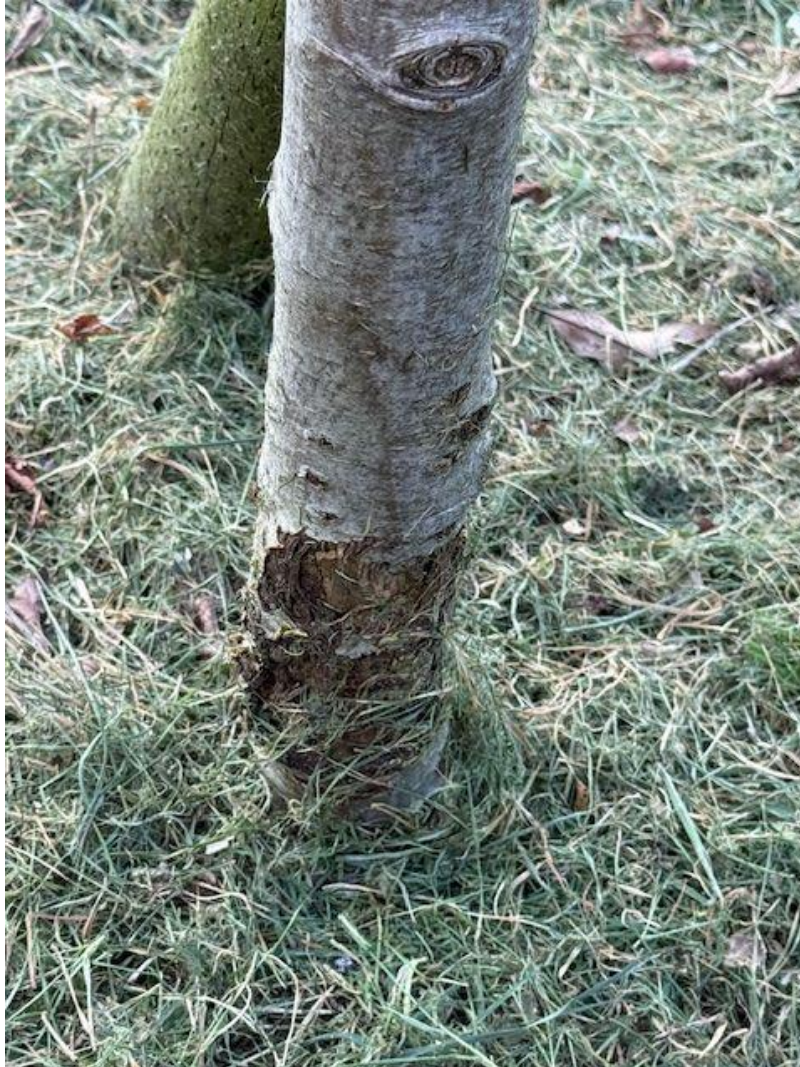
**IMAGE C: Tree 289A showing grass cutting machinery damage to bark.**

| 289A N/T | Rowan N/T | Y | S | F | F | Located 5 metres to the north of tree 290. Remove stake and tree tie within 12 months. Install a strimmer guard to protect the base of the tree from damage by grass cutting machinery - IMAGE C. | 2 | L |
